**Draft
Environmental Assessment

For the
Rio Grande Nature Center Habitat Restoration Project**

U.S. Army Corps of Engineers
Albuquerque District**

February 21, 2006

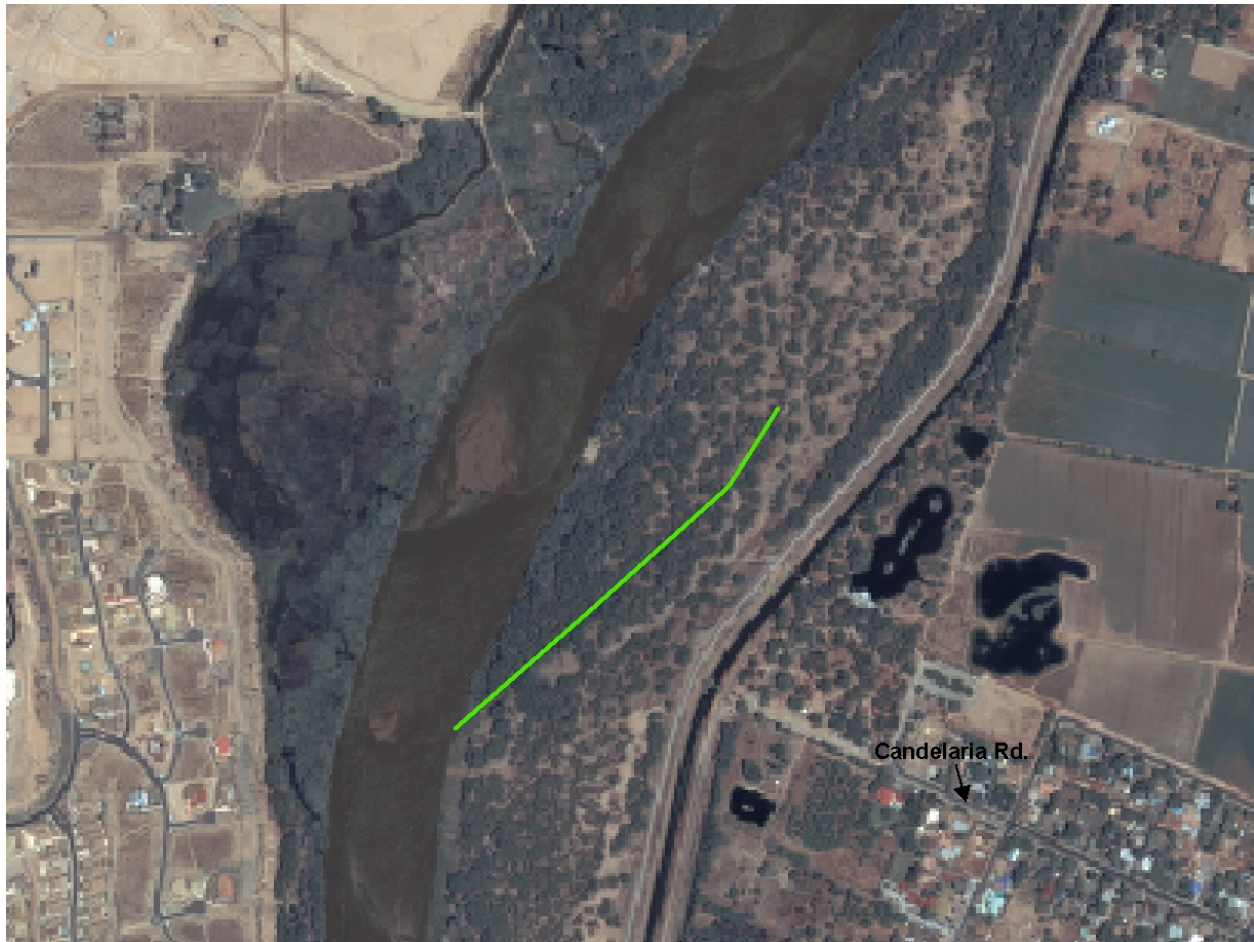
Figure 2. Rio Grande Nature Center State Park site showing remnant channel (June 2005 aerial photography).

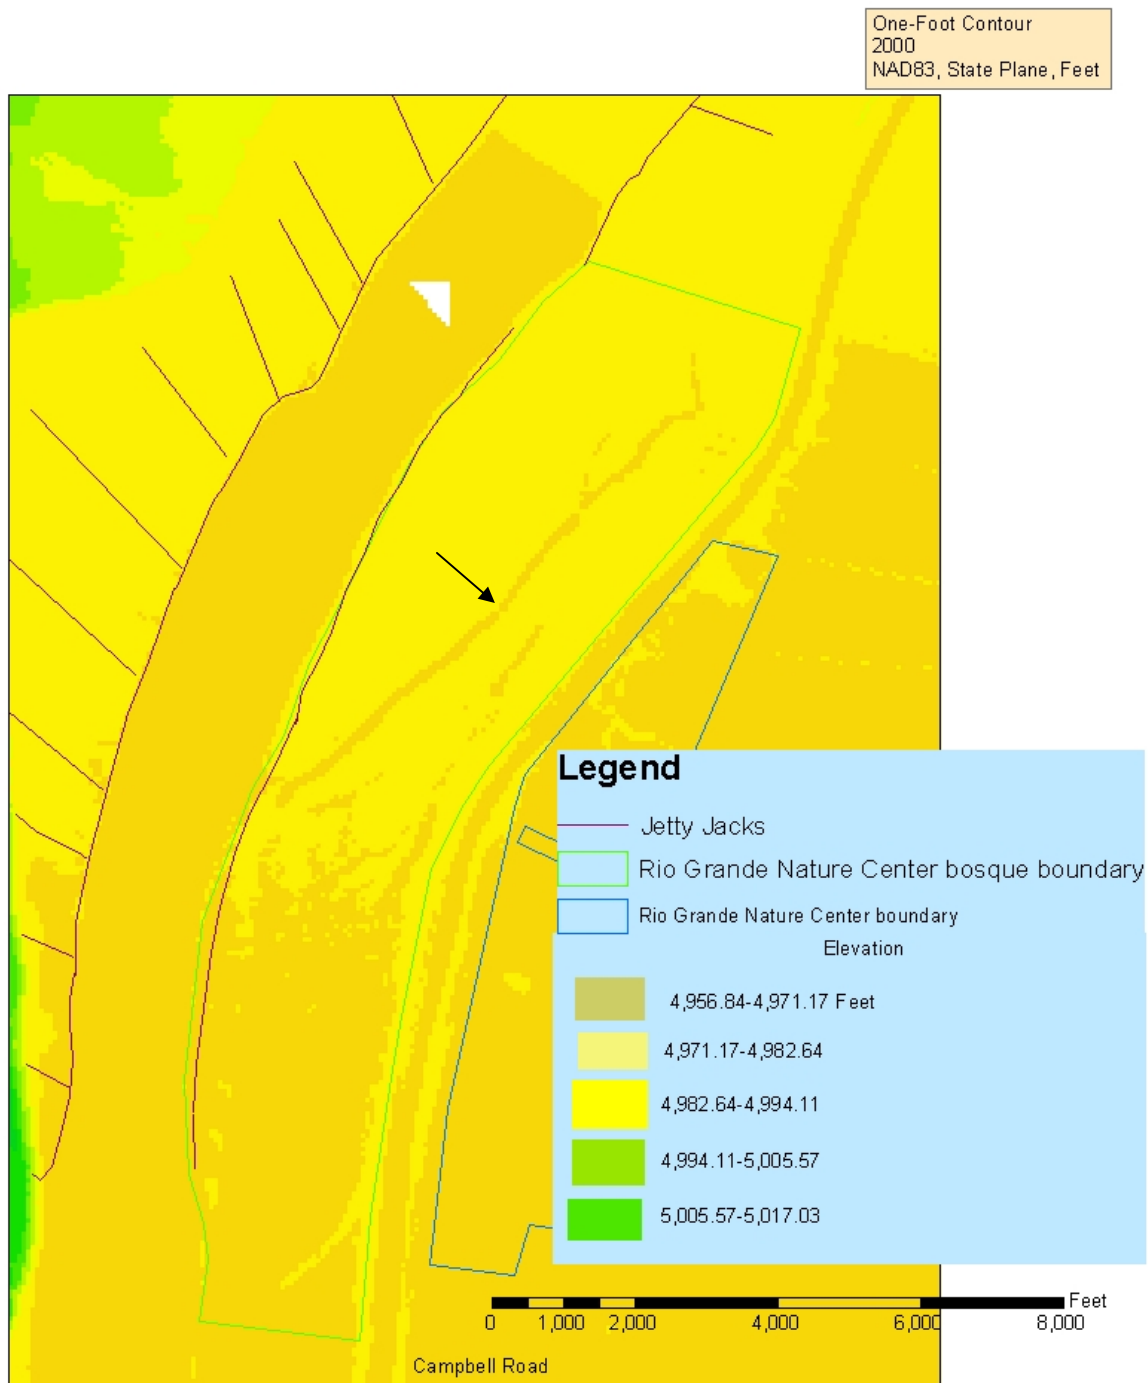
Contour map of proposed project: Rio Grande Nature Center Habitat Restoration

Figure 4. Orthophotography showing existing remnant channel at lower elevation than surrounding bosque.

The Rio Grande Nature Center site was evaluated and looked at closer using orthophotography (see Figure 4), to determine if the remnant channel could feasibly be reconnected to the river. Under the goal of reconnecting the channel, another alternative was looked at allowing a straighter connection to the north of the existing channel (see Figure 5). This alternative would require additional excavation since the channel would be longer. Under this alternative, approximately 12,700 yd³ would need to be excavated – almost double that of the Proposed Action. This would also require additional ground disturbance, trail crossings and would be more expensive. Therefore, this alternative was eliminated from further consideration.

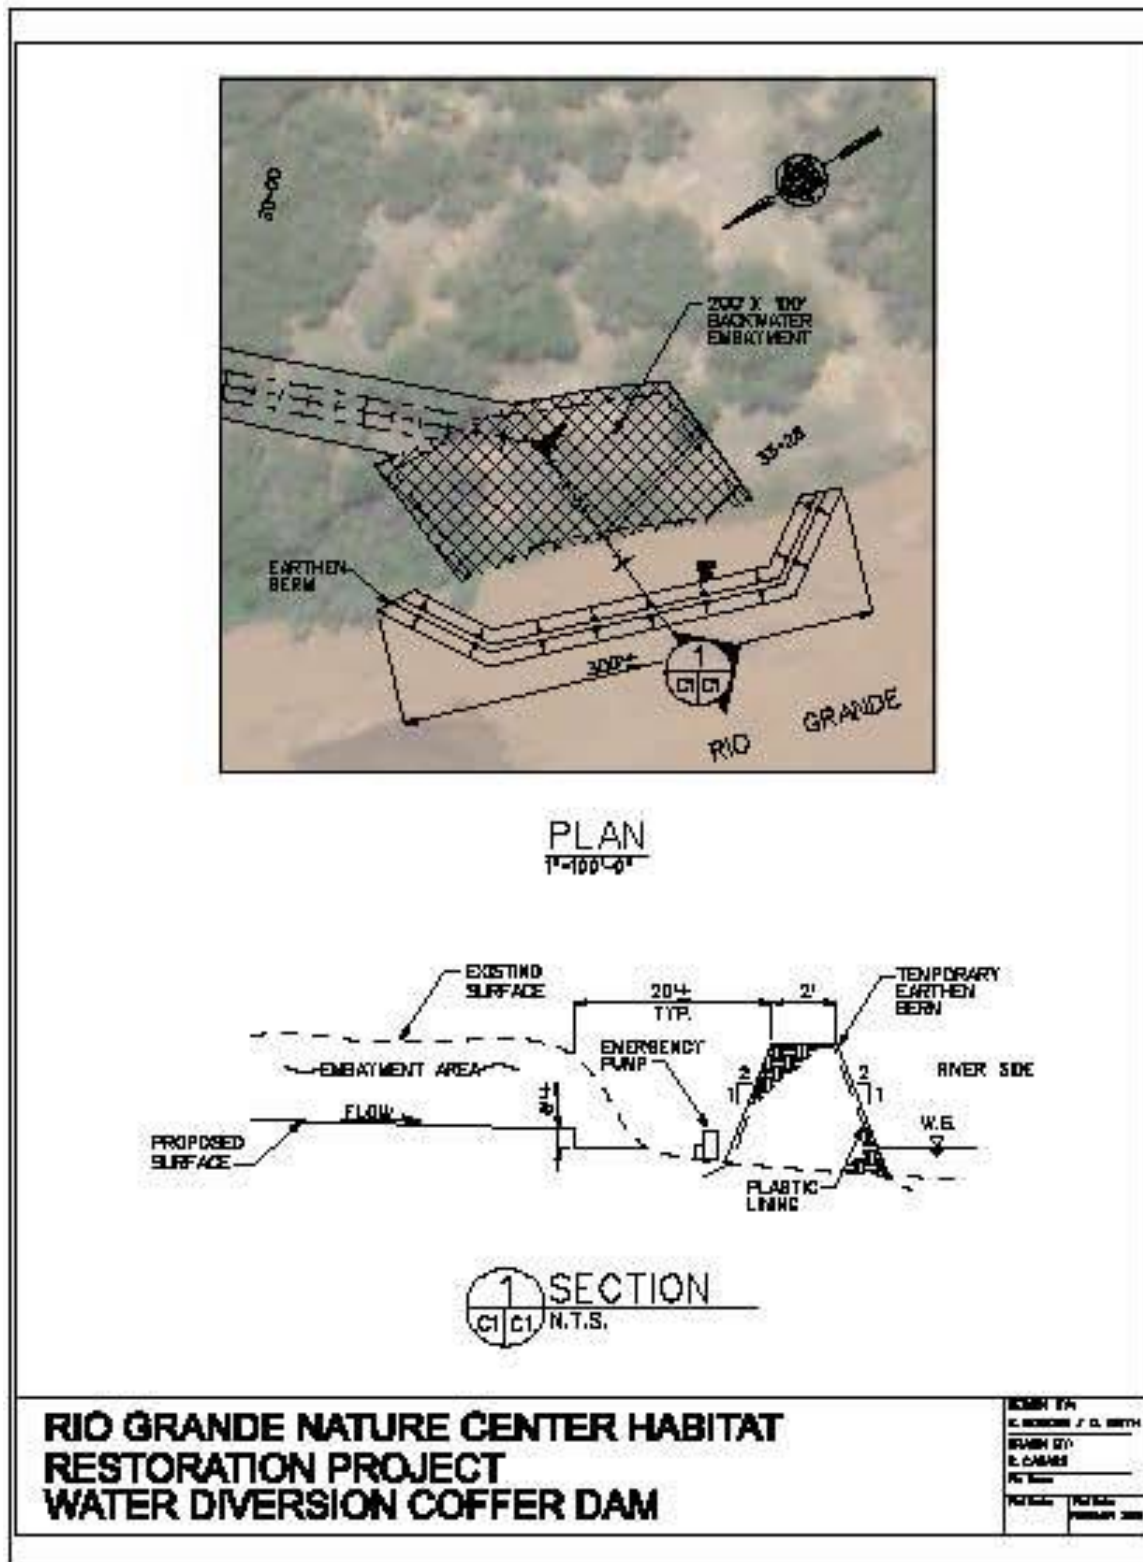
Figure 6. Example of coffer dam

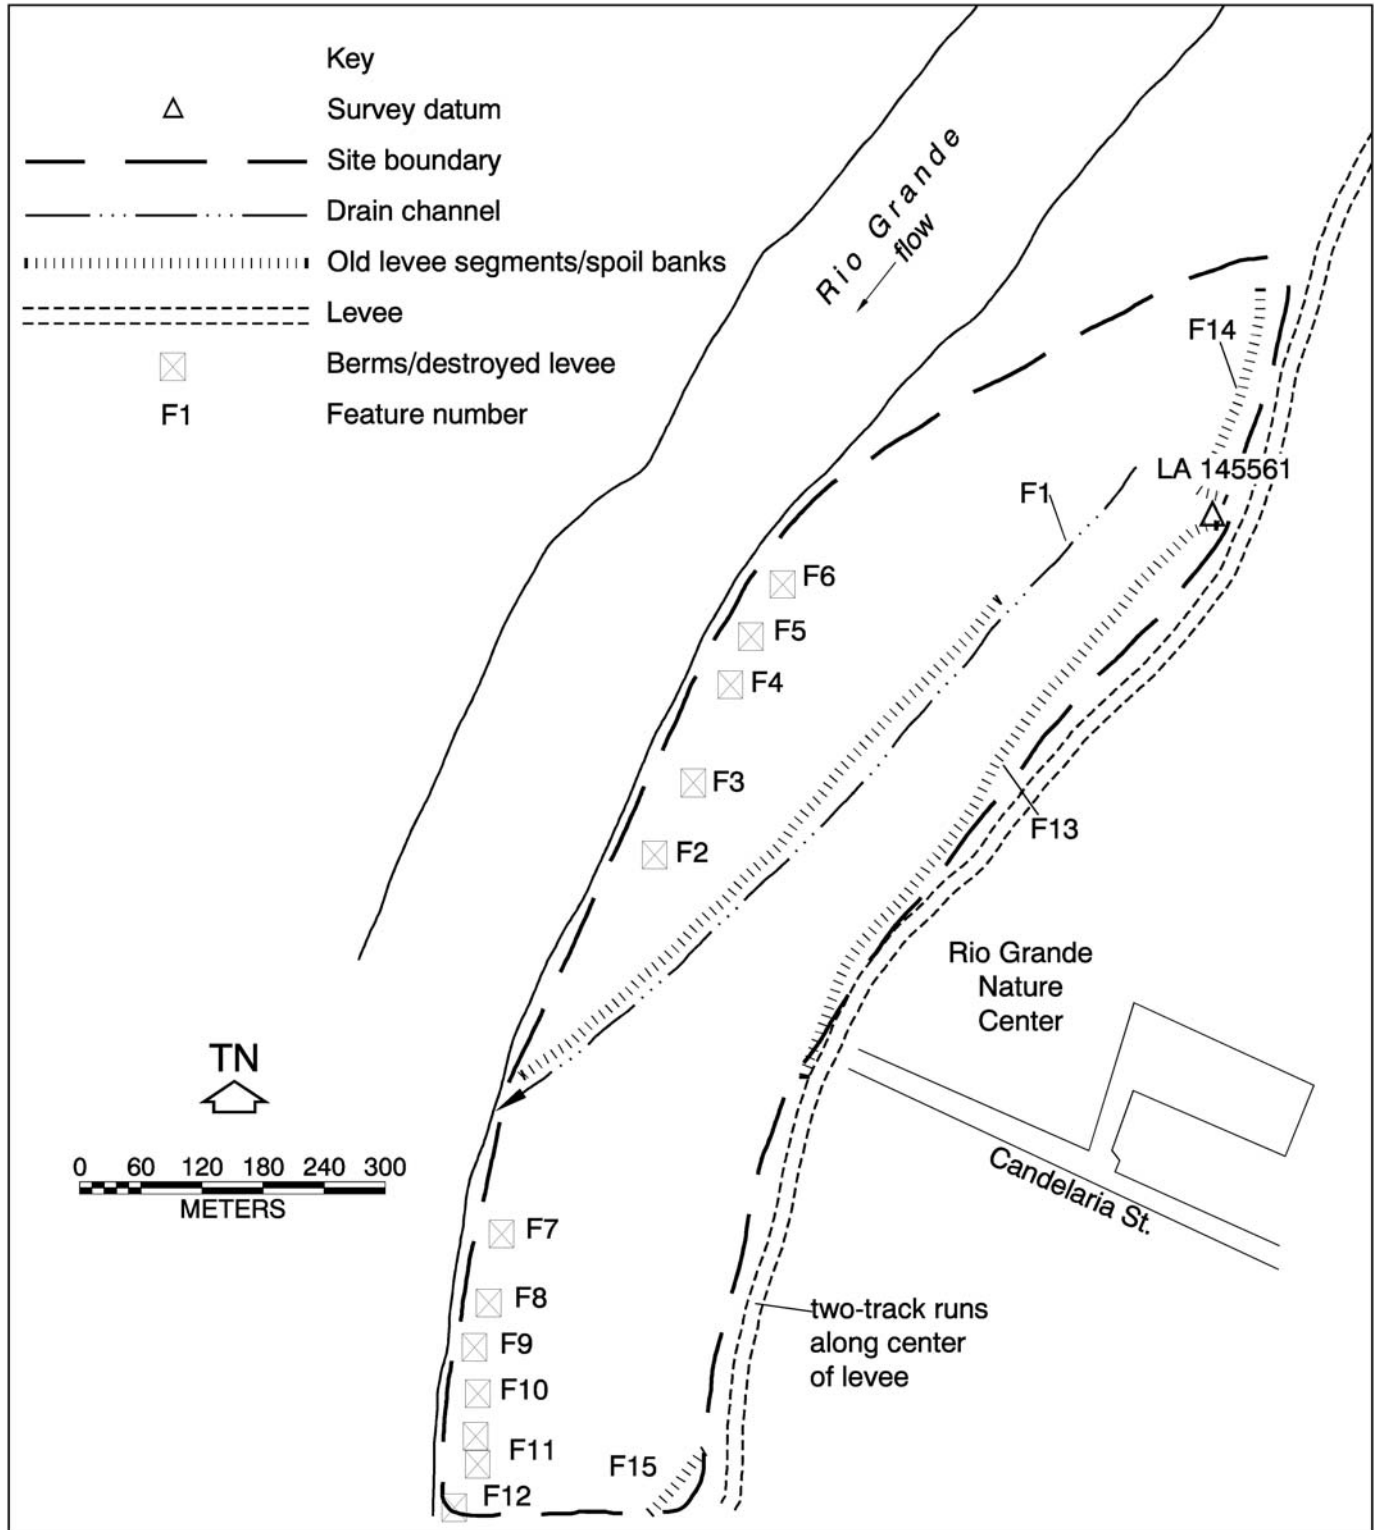
Figure 7. Historic site within the project area

Features 2 through 12 are a series of eleven earthen berms that form a north to south alignment between the river and the drainage ditch. The berms resemble ramps because the northern ends of the berms are at the level of the modern ground surface, and they slope upward to the south reaching a height of 5-6.6 feet (1.5–2 meters). The Los Griegos (1972) quadrangle map shows a levee at the approximate location of the berms. These features may be the remains of a poorly constructed levee that was severely damaged by floods. Another explanation is that these berms were earthen jetties placed at regular intervals along the river.

Features 13, 14, and 15 are discontinuous levee segments along the eastern side of the site adjacent to the contemporary levee. Features 13 and 15 have been impacted by construction of the modern levee, while feature 14 was not affected. These old levee segments are

non-engineered spoil bank levees. LA 145561 has the potential to yield additional information concerning the agricultural development of this portion of the Upper Middle Rio Grande Valley and to document the activities of the Middle Rio Grande Conservancy District, the U.S. Bureau of Reclamation, and the Army Corps of Engineers from the 1930's to the 1960's. The New Mexico State Preservation Officer has concurred with the U.S. Army Corps of Engineers that LA 145561 is eligible for inclusion in the National Register of Historic Places under criteria "a" and "d" of 36 CFR 60.4 (SHPO concurrence dated November 28, 2005, HPD No. 076136).

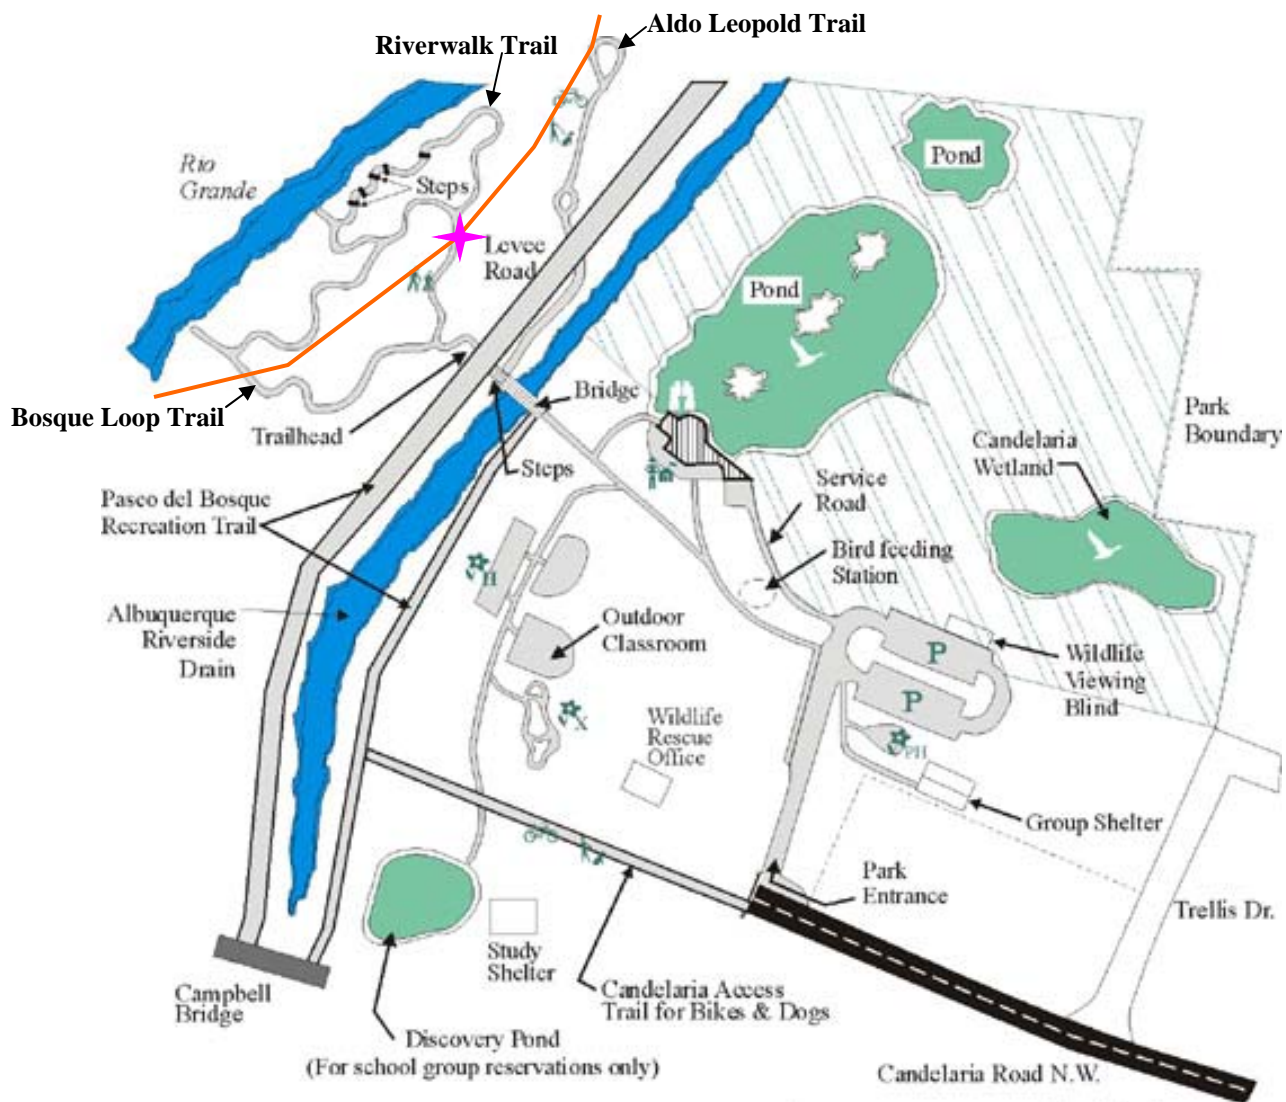
— Approximate location of channel

At the Rio Grande Nature Center State Park (RGNCSP), there are various maintained trails (see Figure 8). The Bosque Loop Trail is a defined trail with a gravel surface. The Riverwalk Trail is a natural surface trail (dirt). The Aldo Leopold Trail is a paved trail. The channel that is proposed to be reworked in the Proposed Action runs adjacent to the Aldo Leopold Trail on the west side of the trail (see Figure 3) and goes under the Bosque Loop Trail where a culvert already exists. The culvert under the Bosque Loop Trail would need to be replaced with a higher capacity crossing such as a con-span crossing. A con-span crossing is a 3-sided culvert that would allow the bottom to be natural material. Some revetment against the Aldo Leopold Trail where the channel runs adjacent to it may also need to be put in place. The channel would also cut across the Bosque Loop Trail where it would connect to the river. A con-span crossing would also be used in this location. Additionally, if the optional embayment is constructed to the north and east of the channel, a crossing of the Aldo Leopold Trail would need to be included. Therefore, the channel would cross the trail in two places (though one crossing already exists at the Bosque Loop Trail) and come up adjacent to the Aldo Leopold Trail where some revetment may need to be put in to keep the trail in place. The two new crossings would also have railings on either side for pedestrians to safely walk across them.

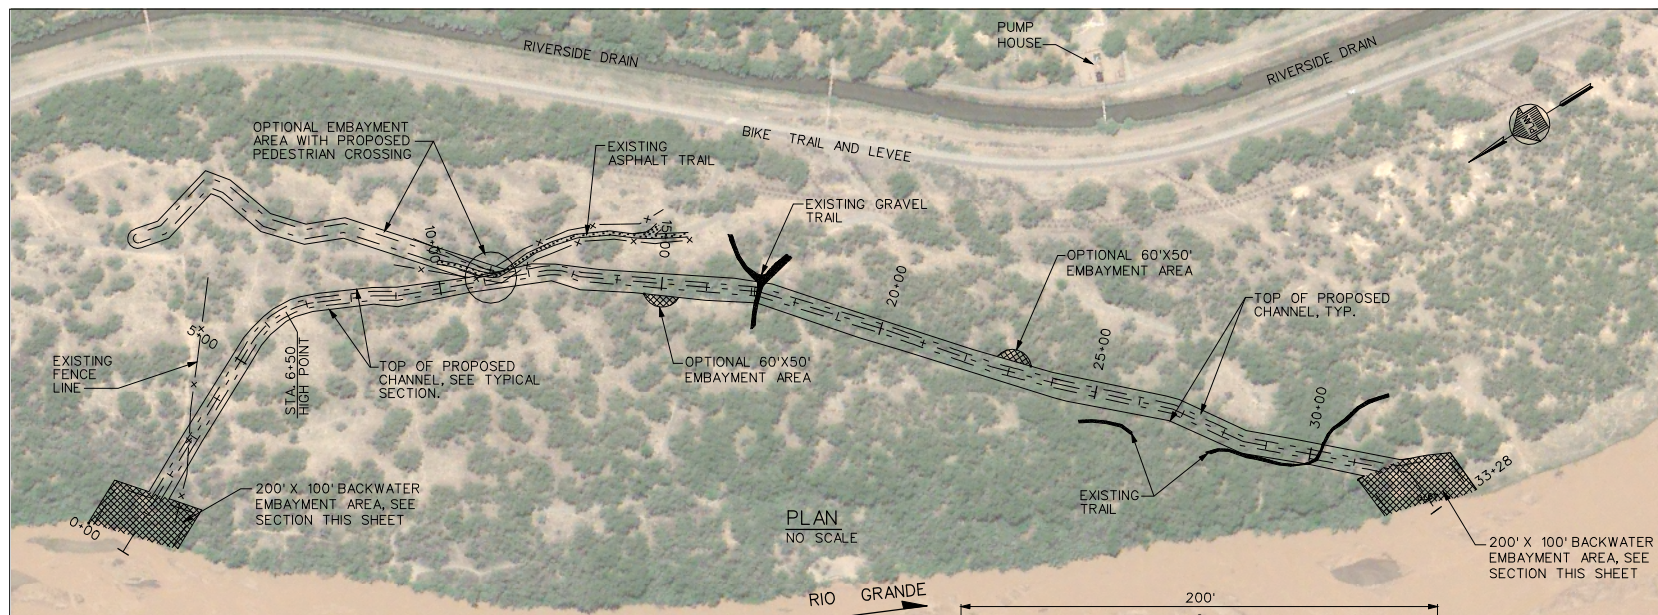
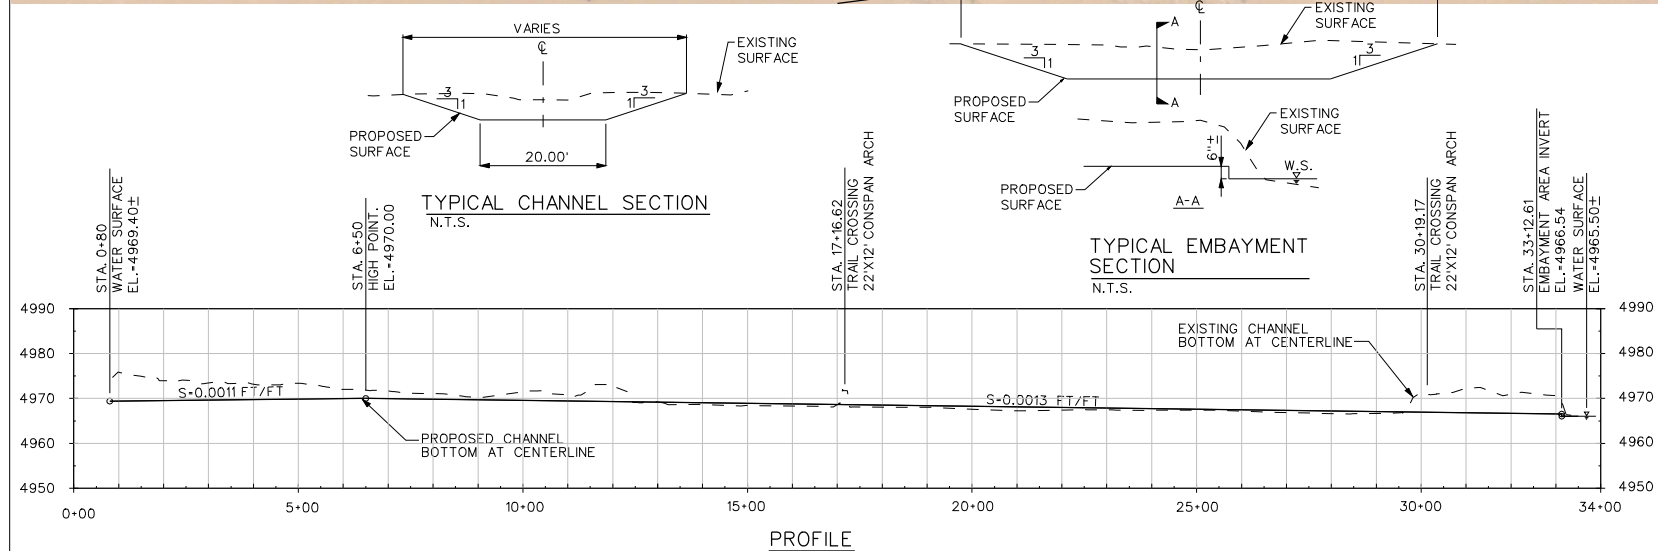
FIGURE 3 - RIO GRANDE NATURE CENTER HABITAT RESTORATION PROJECT PROPOSED ALIGNMENT "A" (PREFERRED ALTERNATIVE)

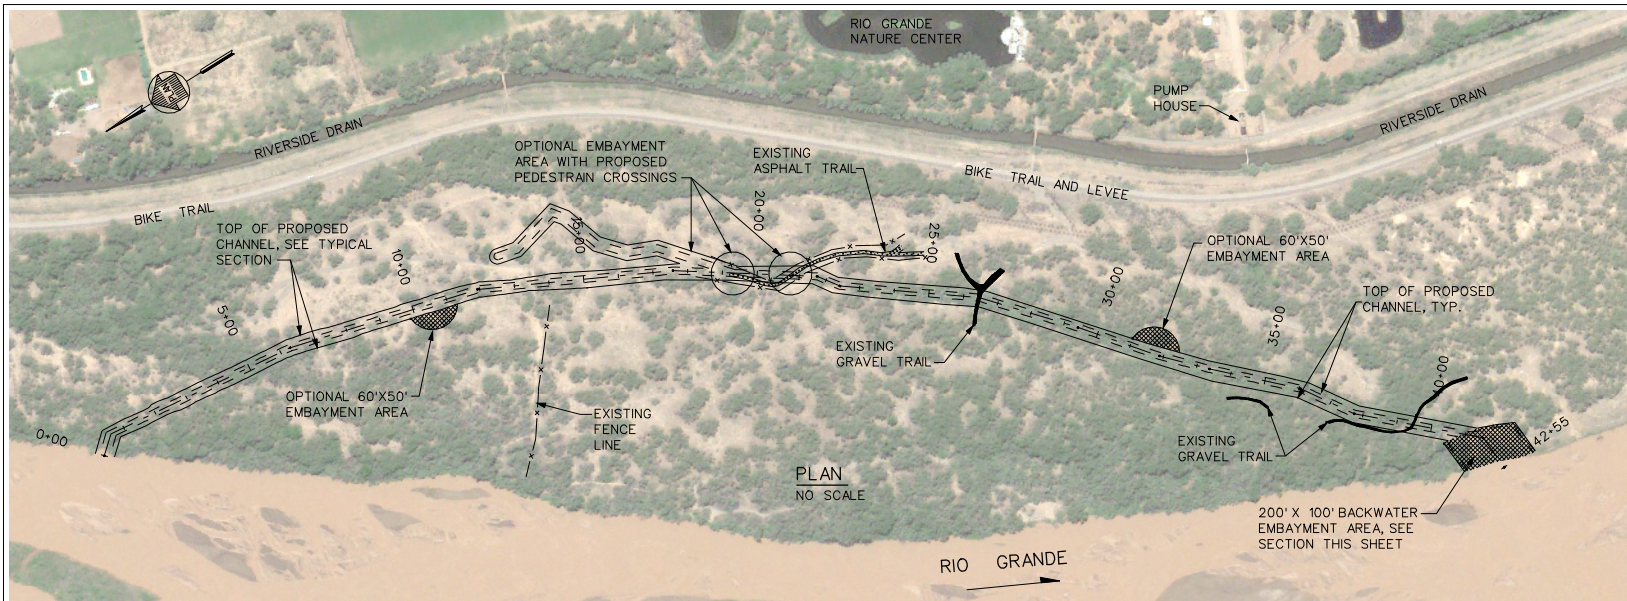
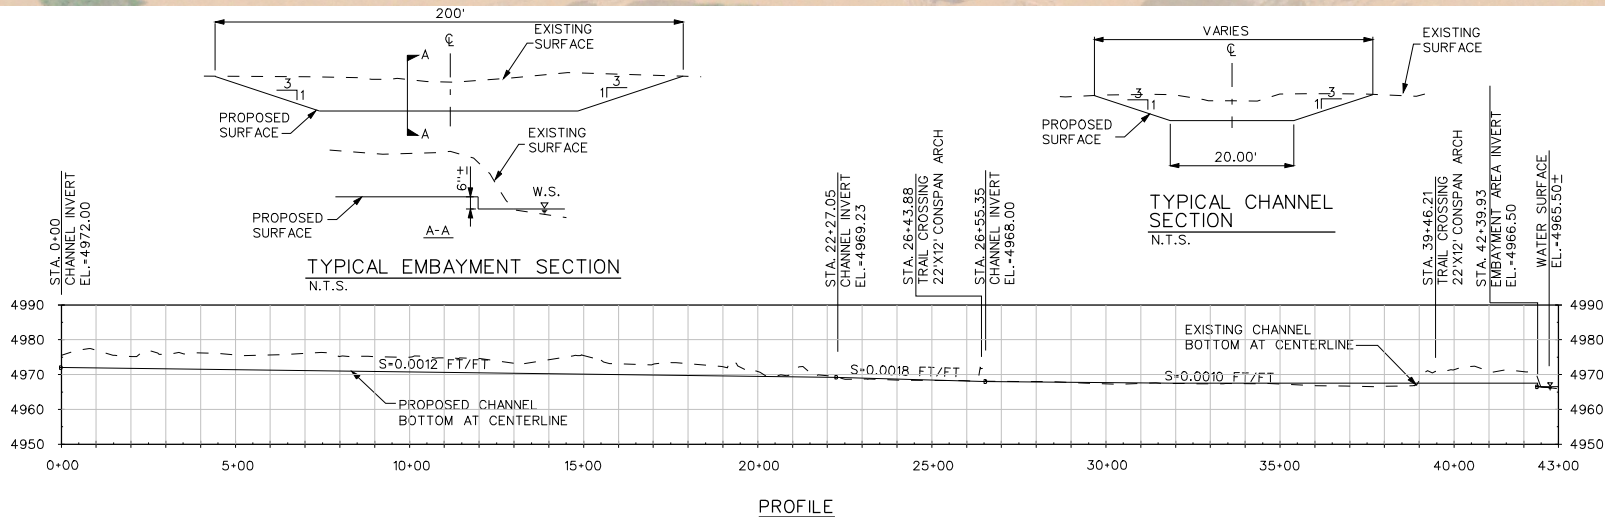
FIGURE 5 - RIO GRANDE NATURE CENTER HABITAT RESTORATION PROJECT PROPOSED ALIGNMENT "B"
